**Steyning Rifle Range:
History and Record of Existing Features**

**Compiled on behalf of the Steyning Downland Scheme
Justin Russell, February 2017**

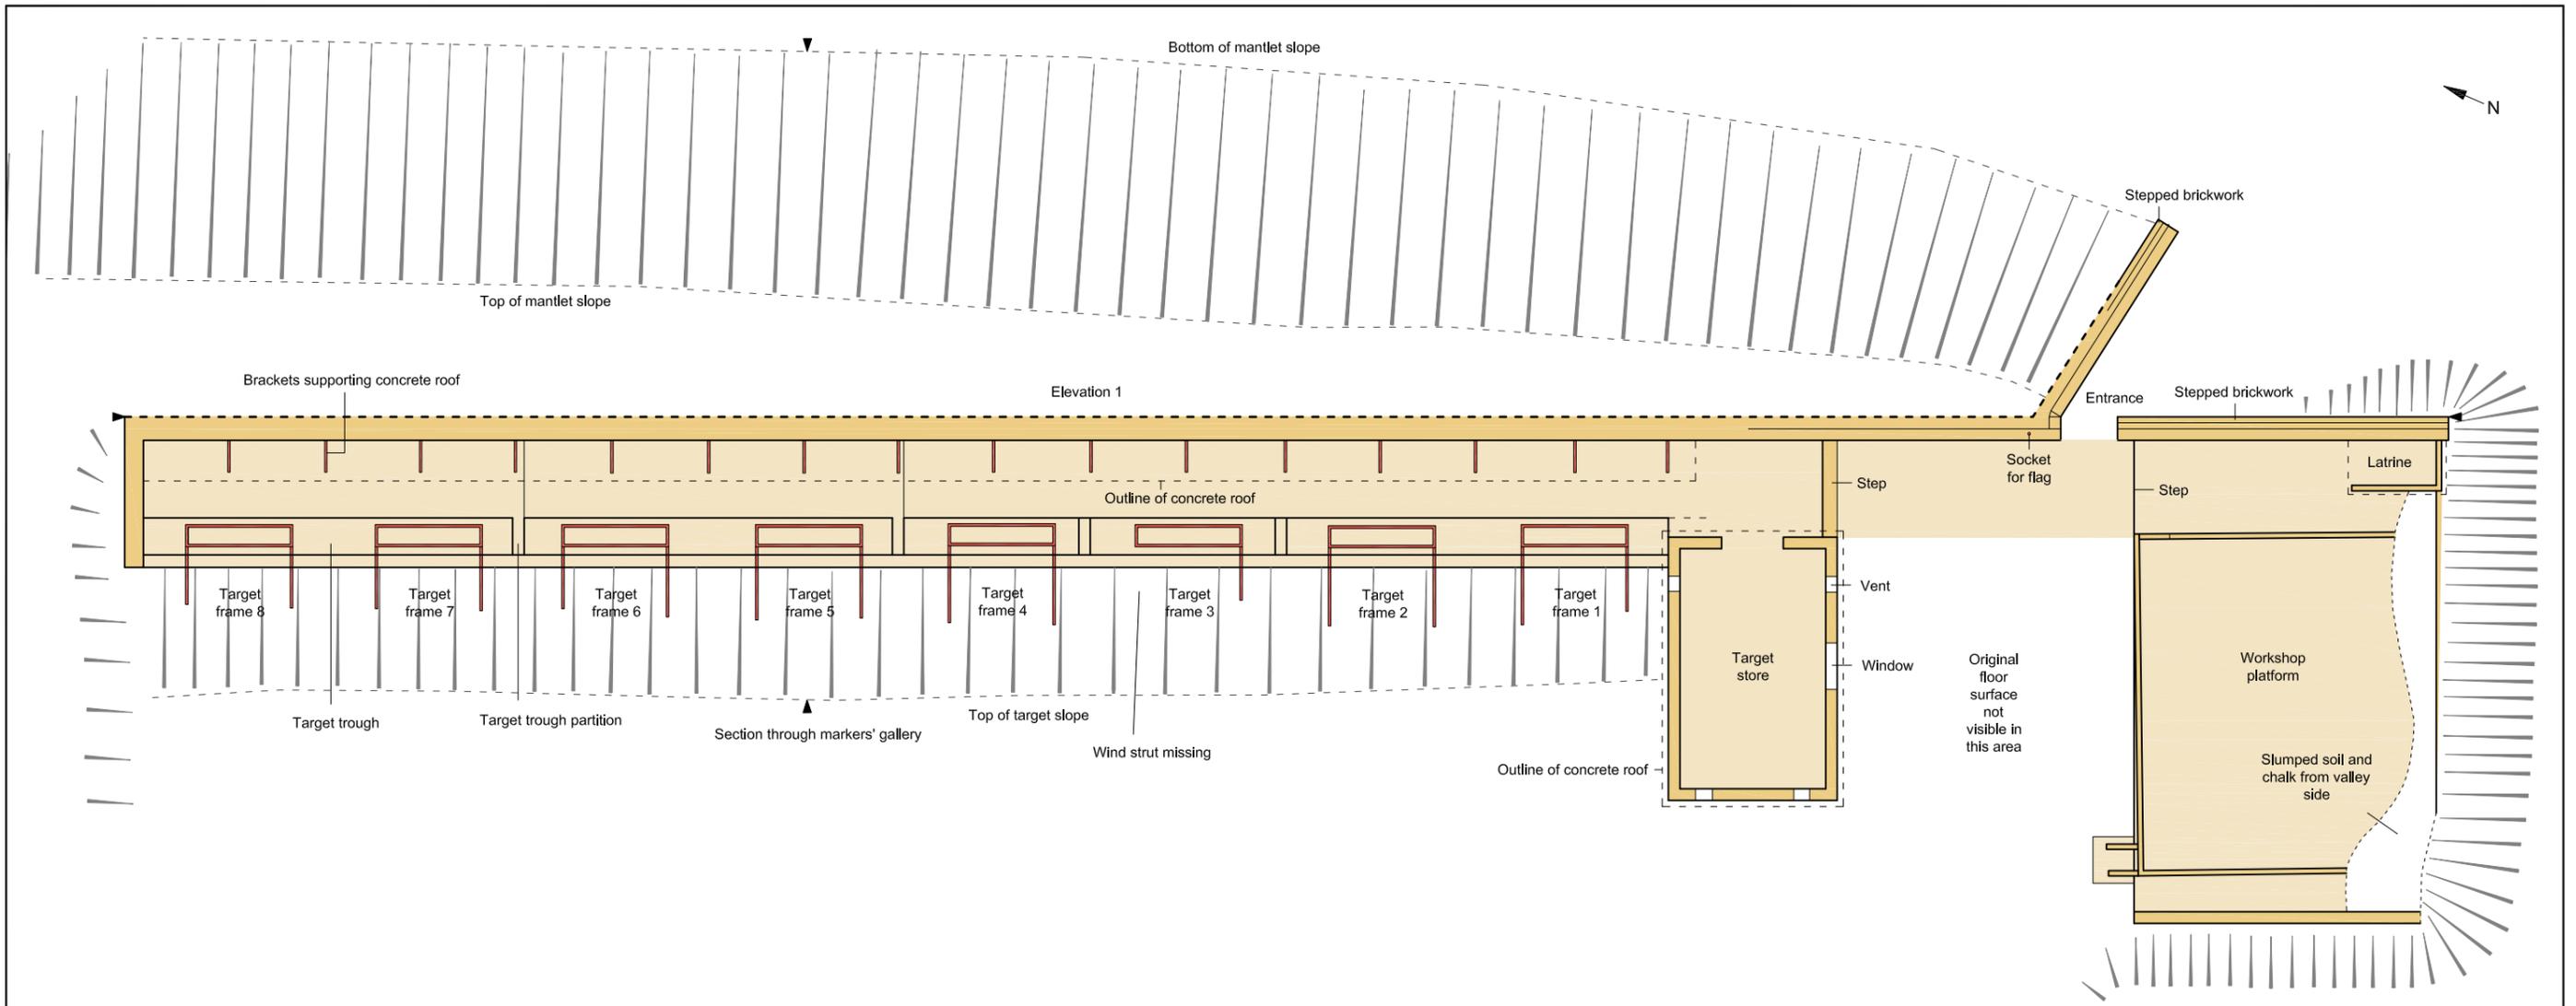
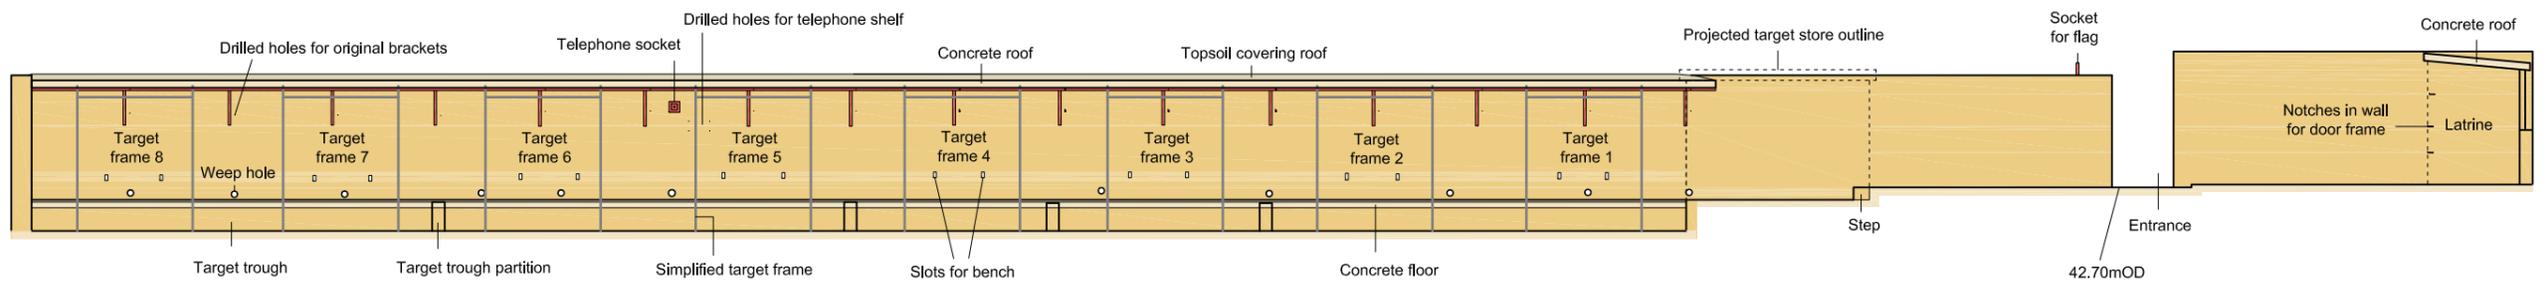
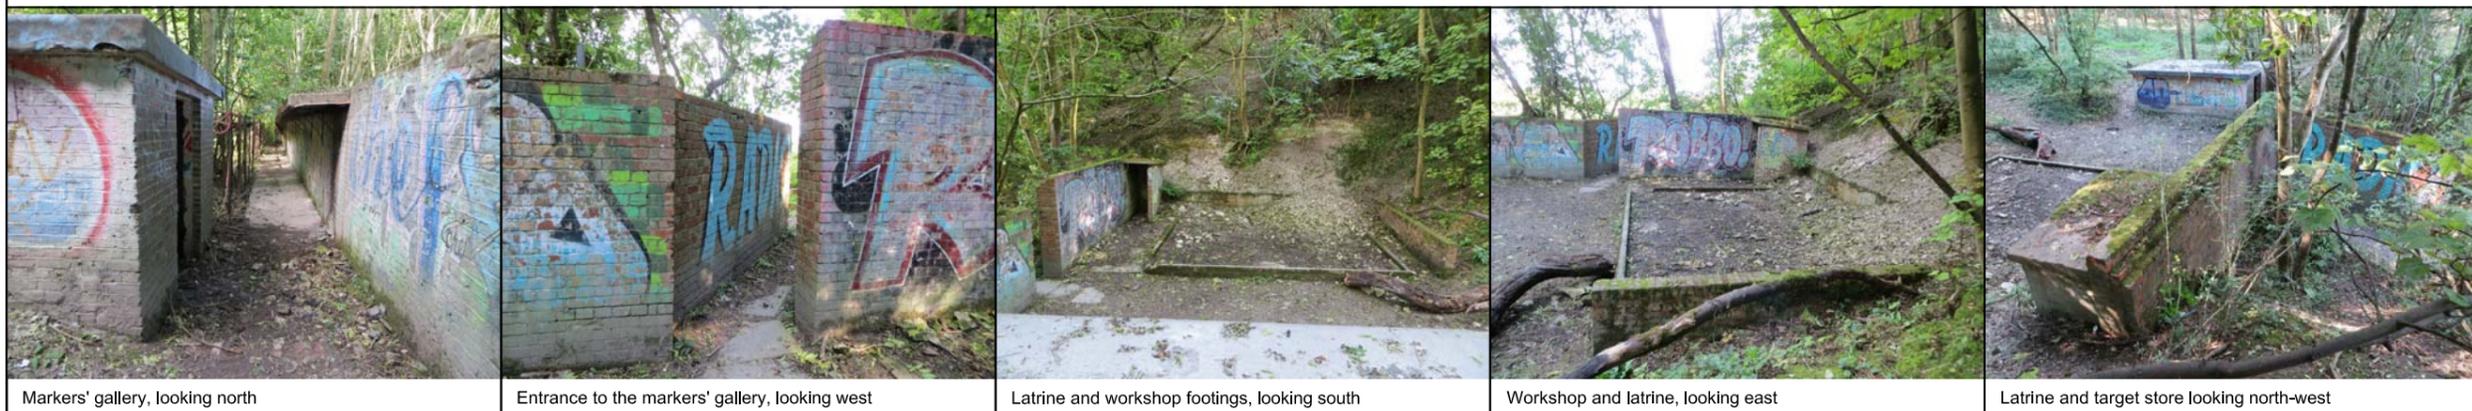
Fig. 15: Plan and elevation of markers' gallery

- 4.5.1 To the south of the entrance is a 9m by 6m concrete platform on which two structures are visible (figure 15). The first is the latrine, built up against the corner formed by the retaining wall (there is, however, no mantlet to retain at this point) and the extreme southern wall of the whole structure. A sloping concrete roof and single skin brick wall form the latrine, which would have housed a receptacle of the Elsan type.
- 4.5.2 The second structure, of which only the brick footings remain, is the workshop. All wooden targets used on site would be constructed or repaired within the

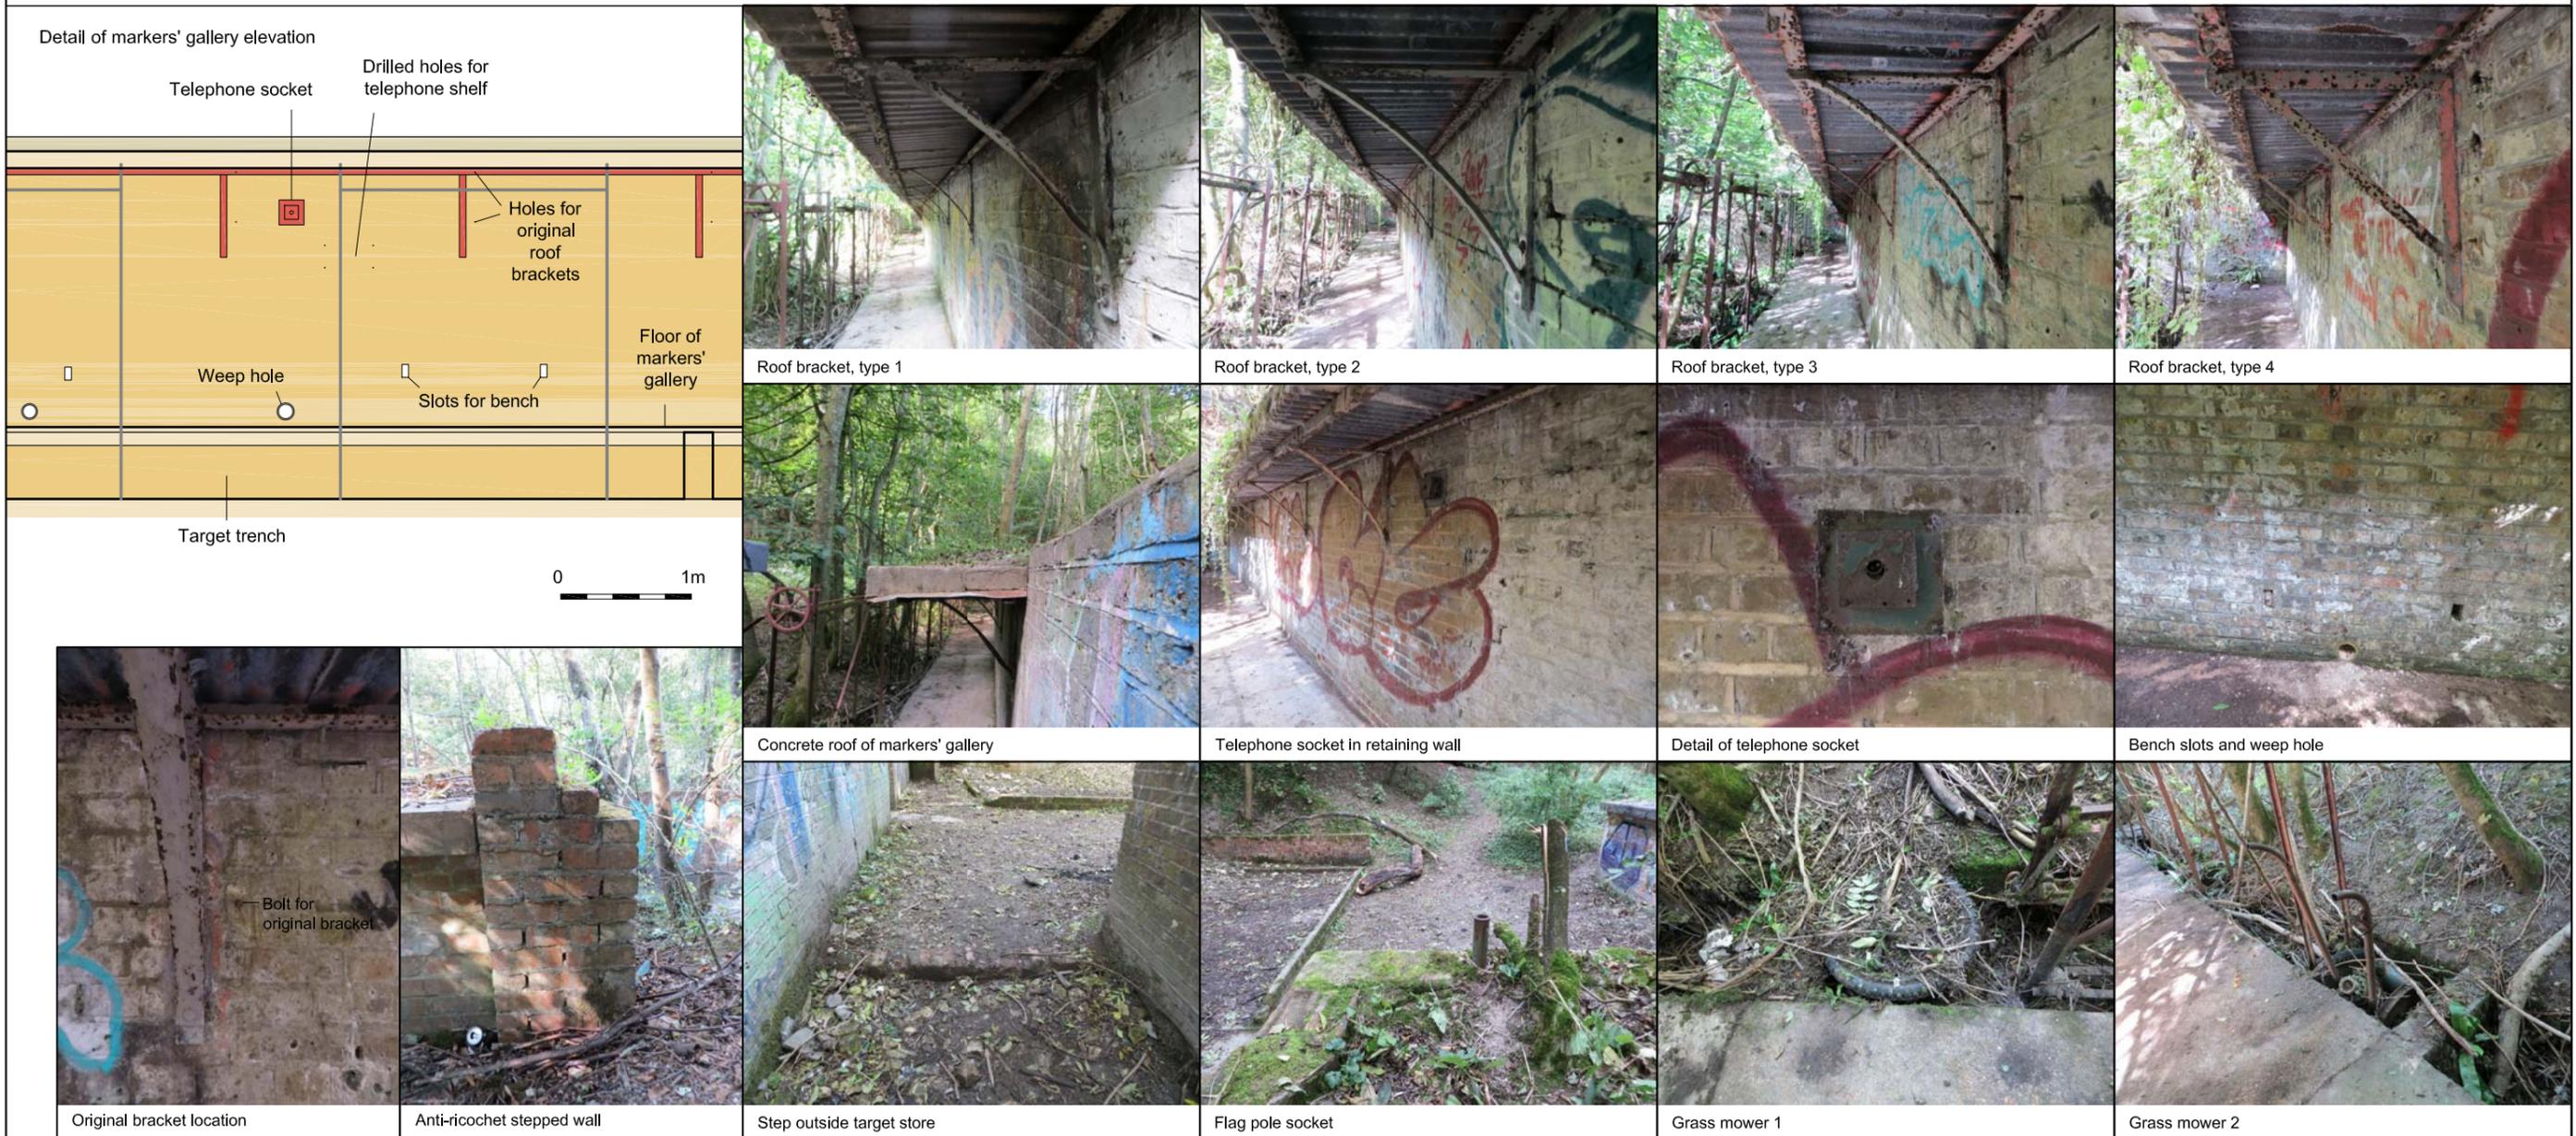
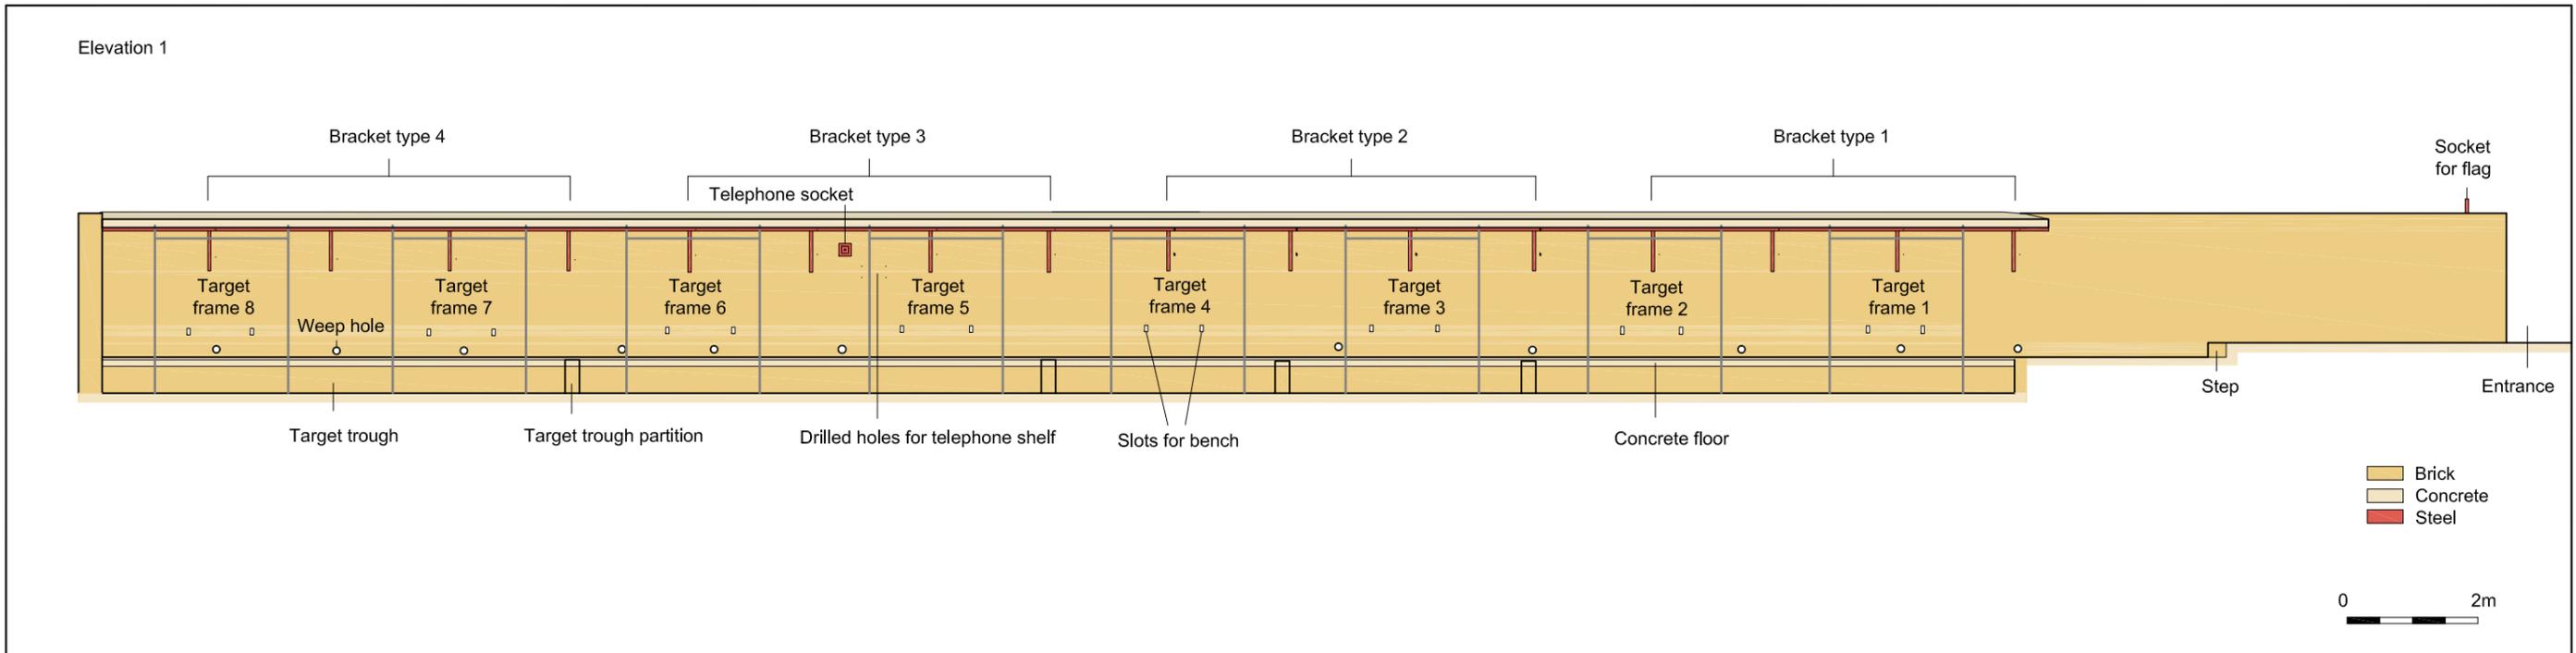
Fig. 16: Markers' gallery details

4.2.2 The roof of the gallery is made of 150mm of concrete, poured onto corrugated and galvanized iron sheets (48 panels with the makers name 'Discus' still visible printed on some), supported by sixteen iron brackets. Soil from the mantlet is spread over the concrete roof to form an upper covering. There are four types of bracket, grouped together in fours. Three types (types 1 – 3) are variations of the same format - two strips of iron joined at almost 90 degrees, strengthened by a curved bracing strip of iron, while the fourth, at the northern end of the gallery (type 4) is a rather more basic design of three strips of angle iron bolted together to form a triangle. A series of bolts protruding from the wall, 120mm to the side and 100mm above all of the existing brackets indicate that the brackets and roof were originally located in a position c. 100mm higher than their current level (figure 16).

- 4.2.4 Slots for benches, comprising eight sets of two slots, are cut into the wall in front of each target, to provide a bench for each marker to sit on (figure 16). At the base of the retaining wall are eleven 'weep holes', ceramic pipes built into the wall and extending into the earth mantlet, serving to drain excess moisture from the bank. The floor of the galley is graded to slope on a 1 in 30 incline to prevent build-up of liquid in the gallery, which drains into the target trenches. This angle is matched in the roof, though in that instance, it is an anti-ricochet design.

- 5.2 Cracks in the retaining wall of the markers' gallery and roof of the target store could be assessed by a structural engineer, though it seems unlikely either are major problems. More pressing, perhaps, is the heavy concrete roof of the markers gallery, supported by sixteen iron brackets bolted to the wall. The trees now growing on top of the mantlet appear to be growing over the roof in some cases and roots of others will undoubtedly be exerting some additional pressure on the structure, compromising its stability.

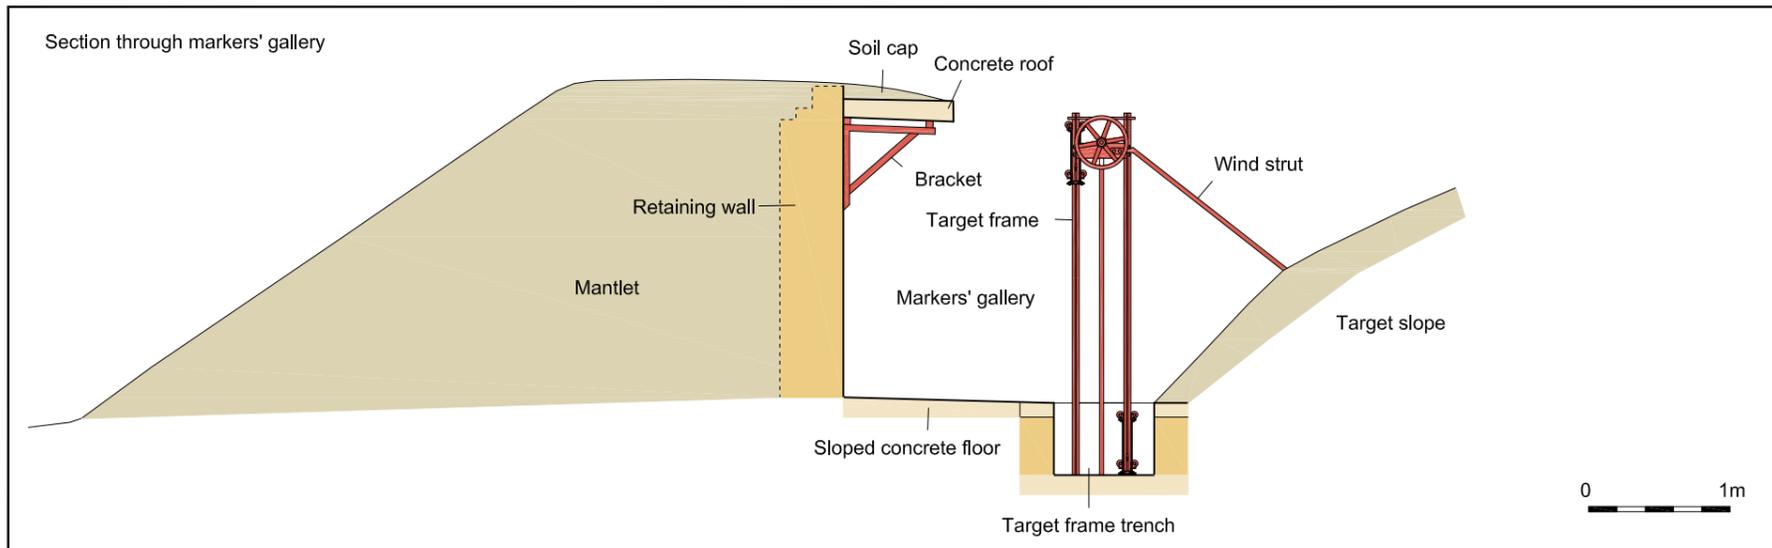
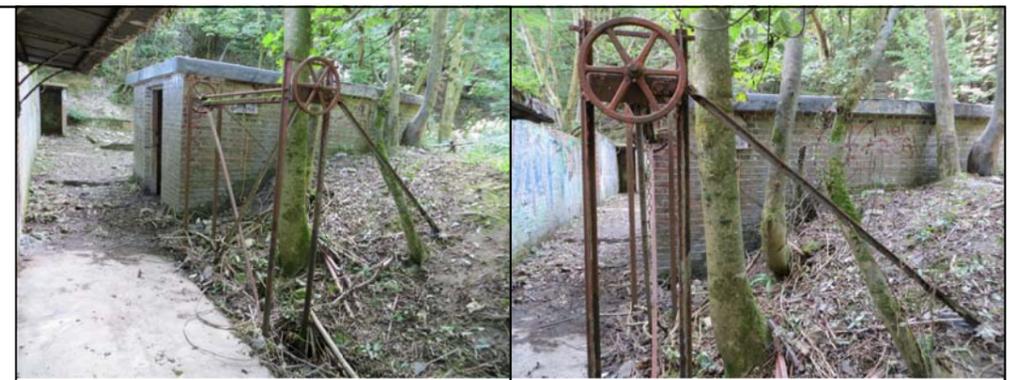
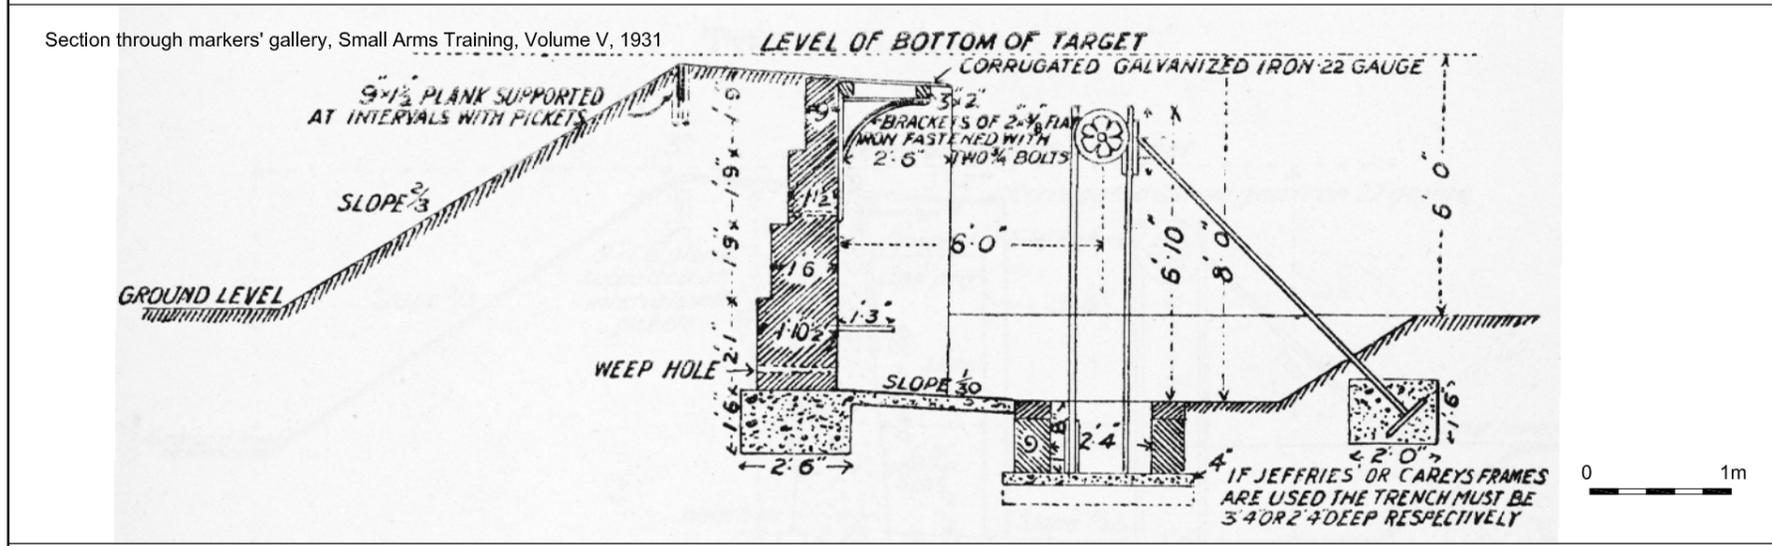
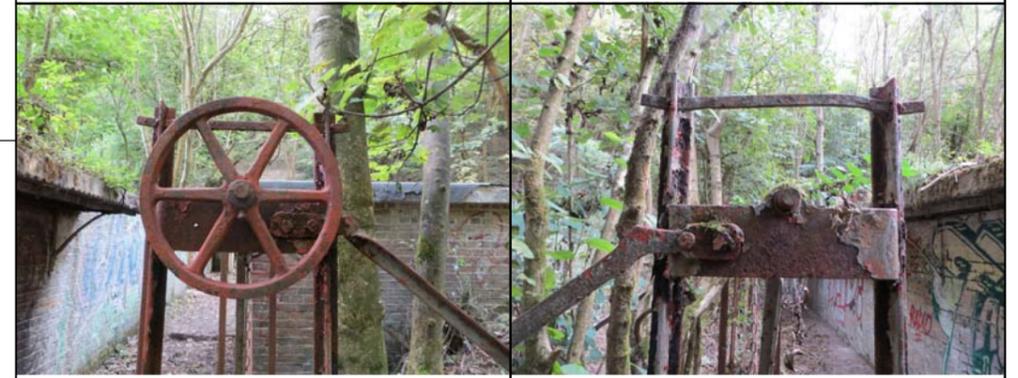
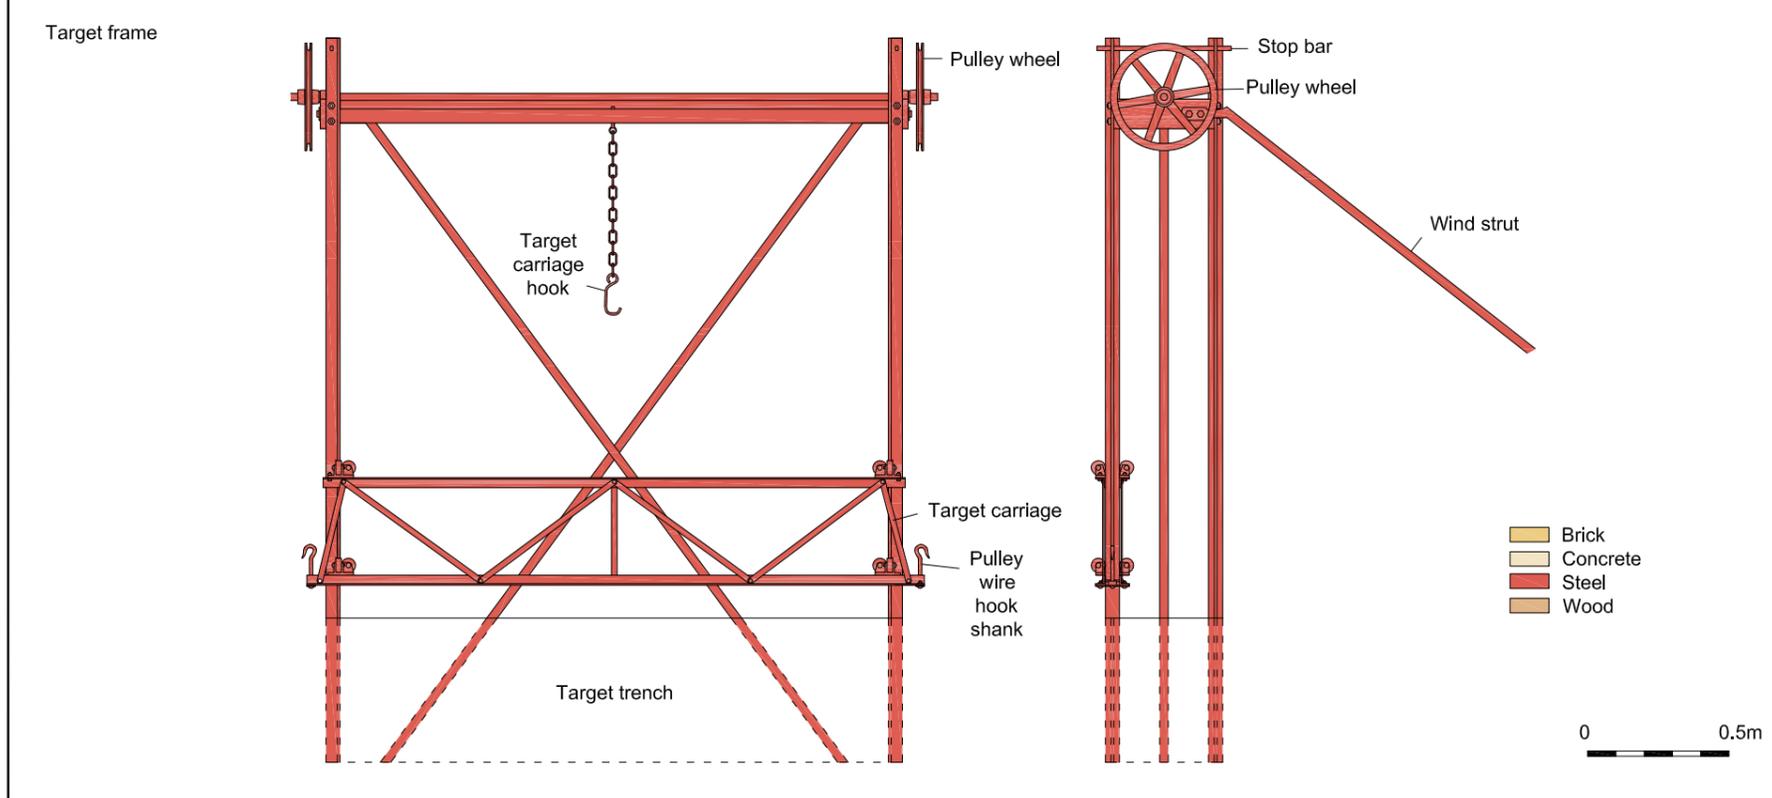
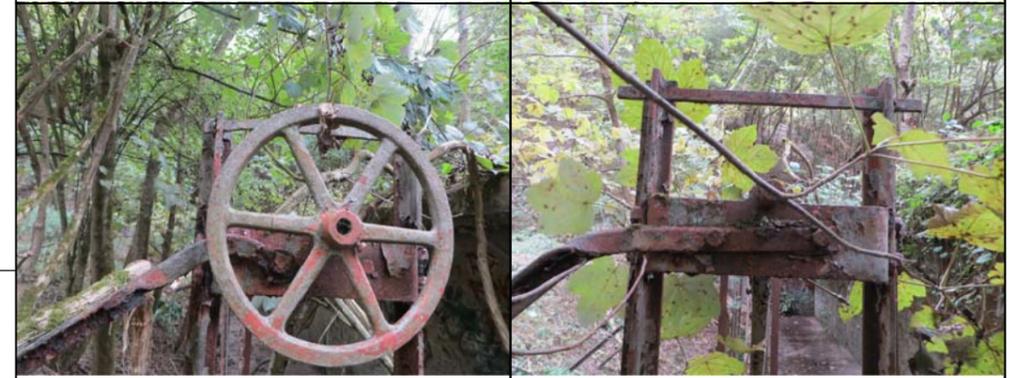
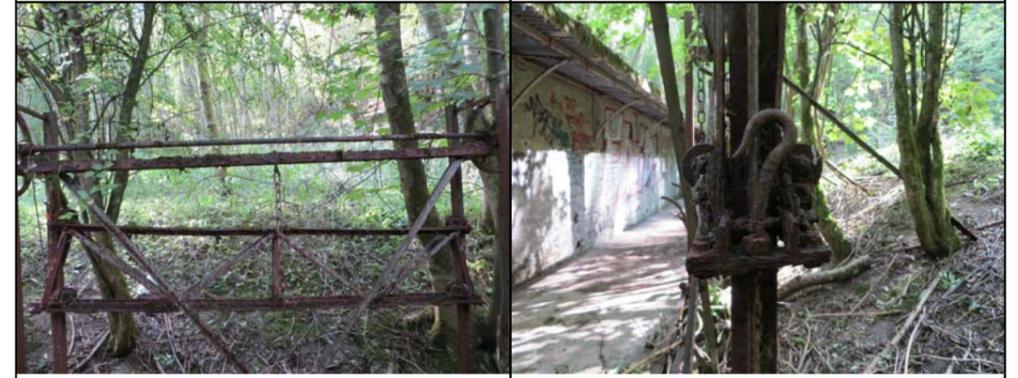
Fig. 17: Section through markers' gallery and target frame detail

- 4.2.6 There are eight target frames, numbered here from south to north, each measuring 2.04m in length and 2.56m in height (figure 17). These are known as 'Hythe' target frames after the School of Musketry at Hythe, Kent. Designed to sit entirely behind the mantlet, none of the metal frame is visible at any of the firing positions, hence not liable to be hit by bullets and cause ricochets. Each frame has two carriages, front and rear, into which the wooden targets are slotted. Measuring 4 feet square (or 6 feet, for distant firing positions) the wooden frameworks were covered in canvas and faced with a paper target. The carriages are balanced so that a wooden target framework in the front carriage could be in the up position, ready to be shot at, while the target framework in the rear carriage would be in the down position and be in the process of repair. Alternatively, a carriage could be weighted down, so that its opposite partner is raised or even hooked into the up position by the chain in the centre of each frame.

- 4.2.7 A thick wound wire is attached to each carriage, looped over the pulley wheel at the top of the target frame and fixed to hook shanks, to assist in the smooth lowering and raising of the targets, aided by wheels on the carriages using the metal frame like a rail. Five of the carriages (targets 3, 4, 6, 7 and 8) are marked with a maker's plate: JEFFRIES SUTTON SURREY ENGLAND. Target frame 7 has a maker's plate: AIMERS MCLEAN + CO LTD. Jeffries frames are mentioned in the 1911 and 1931 manuals (alongside Carey frames) as varieties of the Hythe frame.

- 4.2.8 A wind strut gives the frame stability and, according to the 1931 Small Arms Training manual, should be embedded in a block of concrete within the slope leading down to the markers' gallery. There are three types of wind strut present, type 1 fixed to target frames 1 and 2, type 2 attached to target frames 3 and 4 and type 3 used with the remaining target frames. Type 1 features a small head with two bolts attaching it to the main frame and a pronounced 'elbow' where the strut changes from horizontal to the angled descent into the concrete fixing block. Type 2 features a small round head, one bolt attaching it the frame and a rounded curve connecting it to the angled piece. Type 3 is characterised by the long head by which it is attached to the frame by two bolts and a curve at the change in angle. The minor variation in frames in the gallery could be down to them having been brought in second hand from another site, rather than purchased as new.

- 5.4 The target frames could benefit from an overall clearance of the vegetation and soil surrounding their bases in the target trench. Perhaps a coat of rust proof paint would ensure continued preservation.

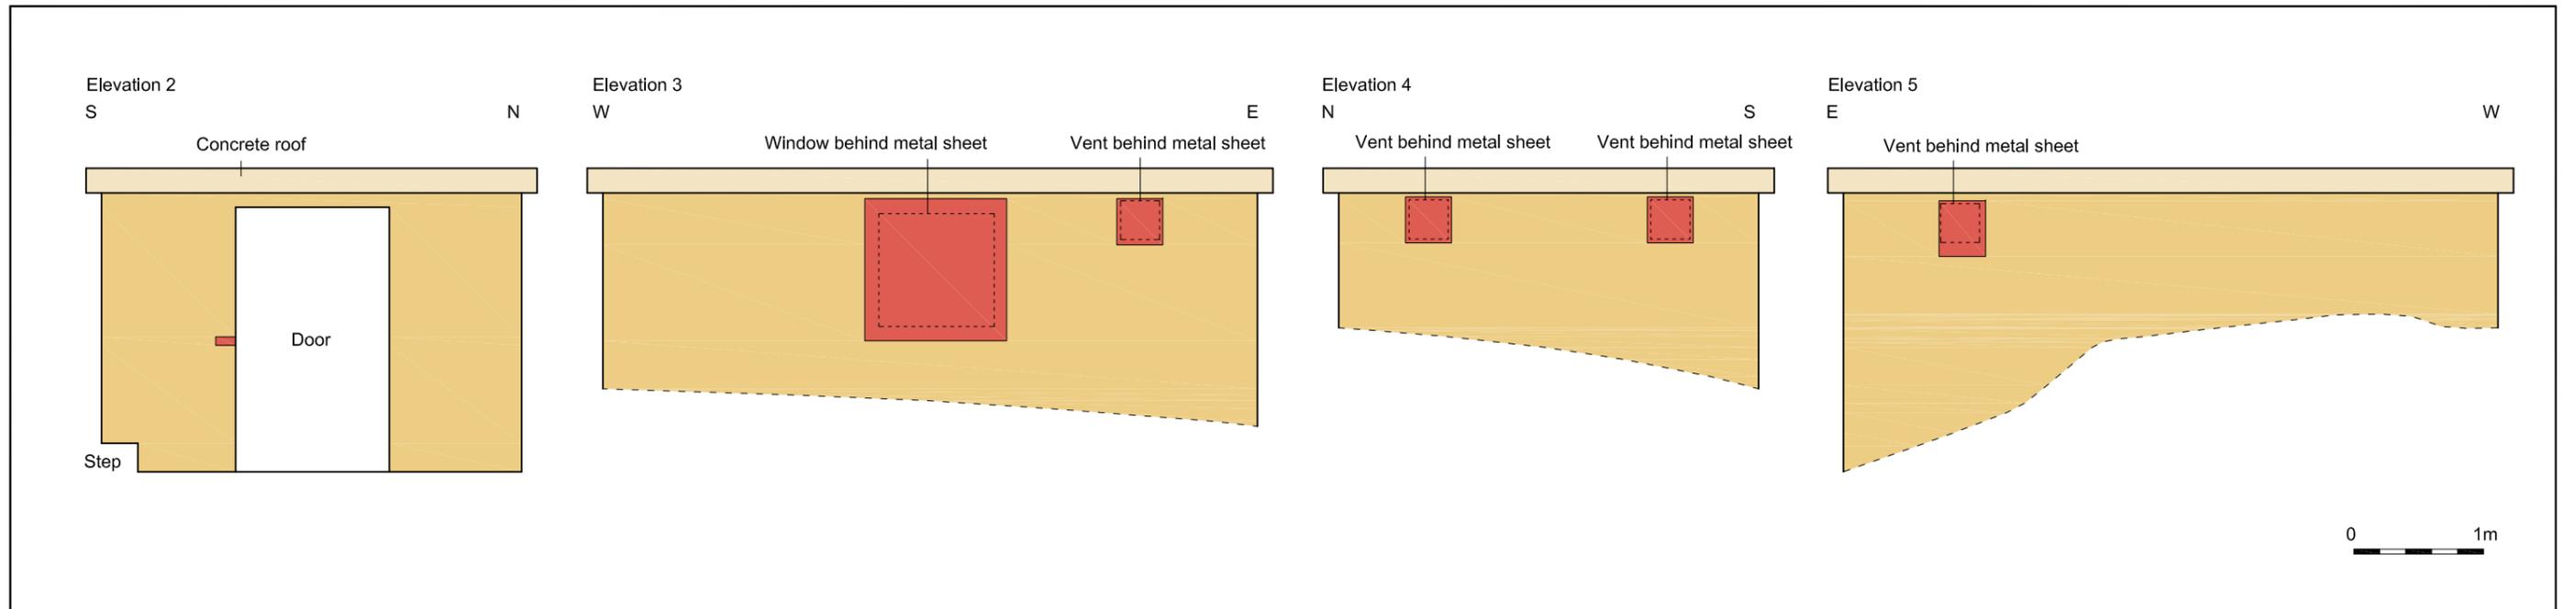
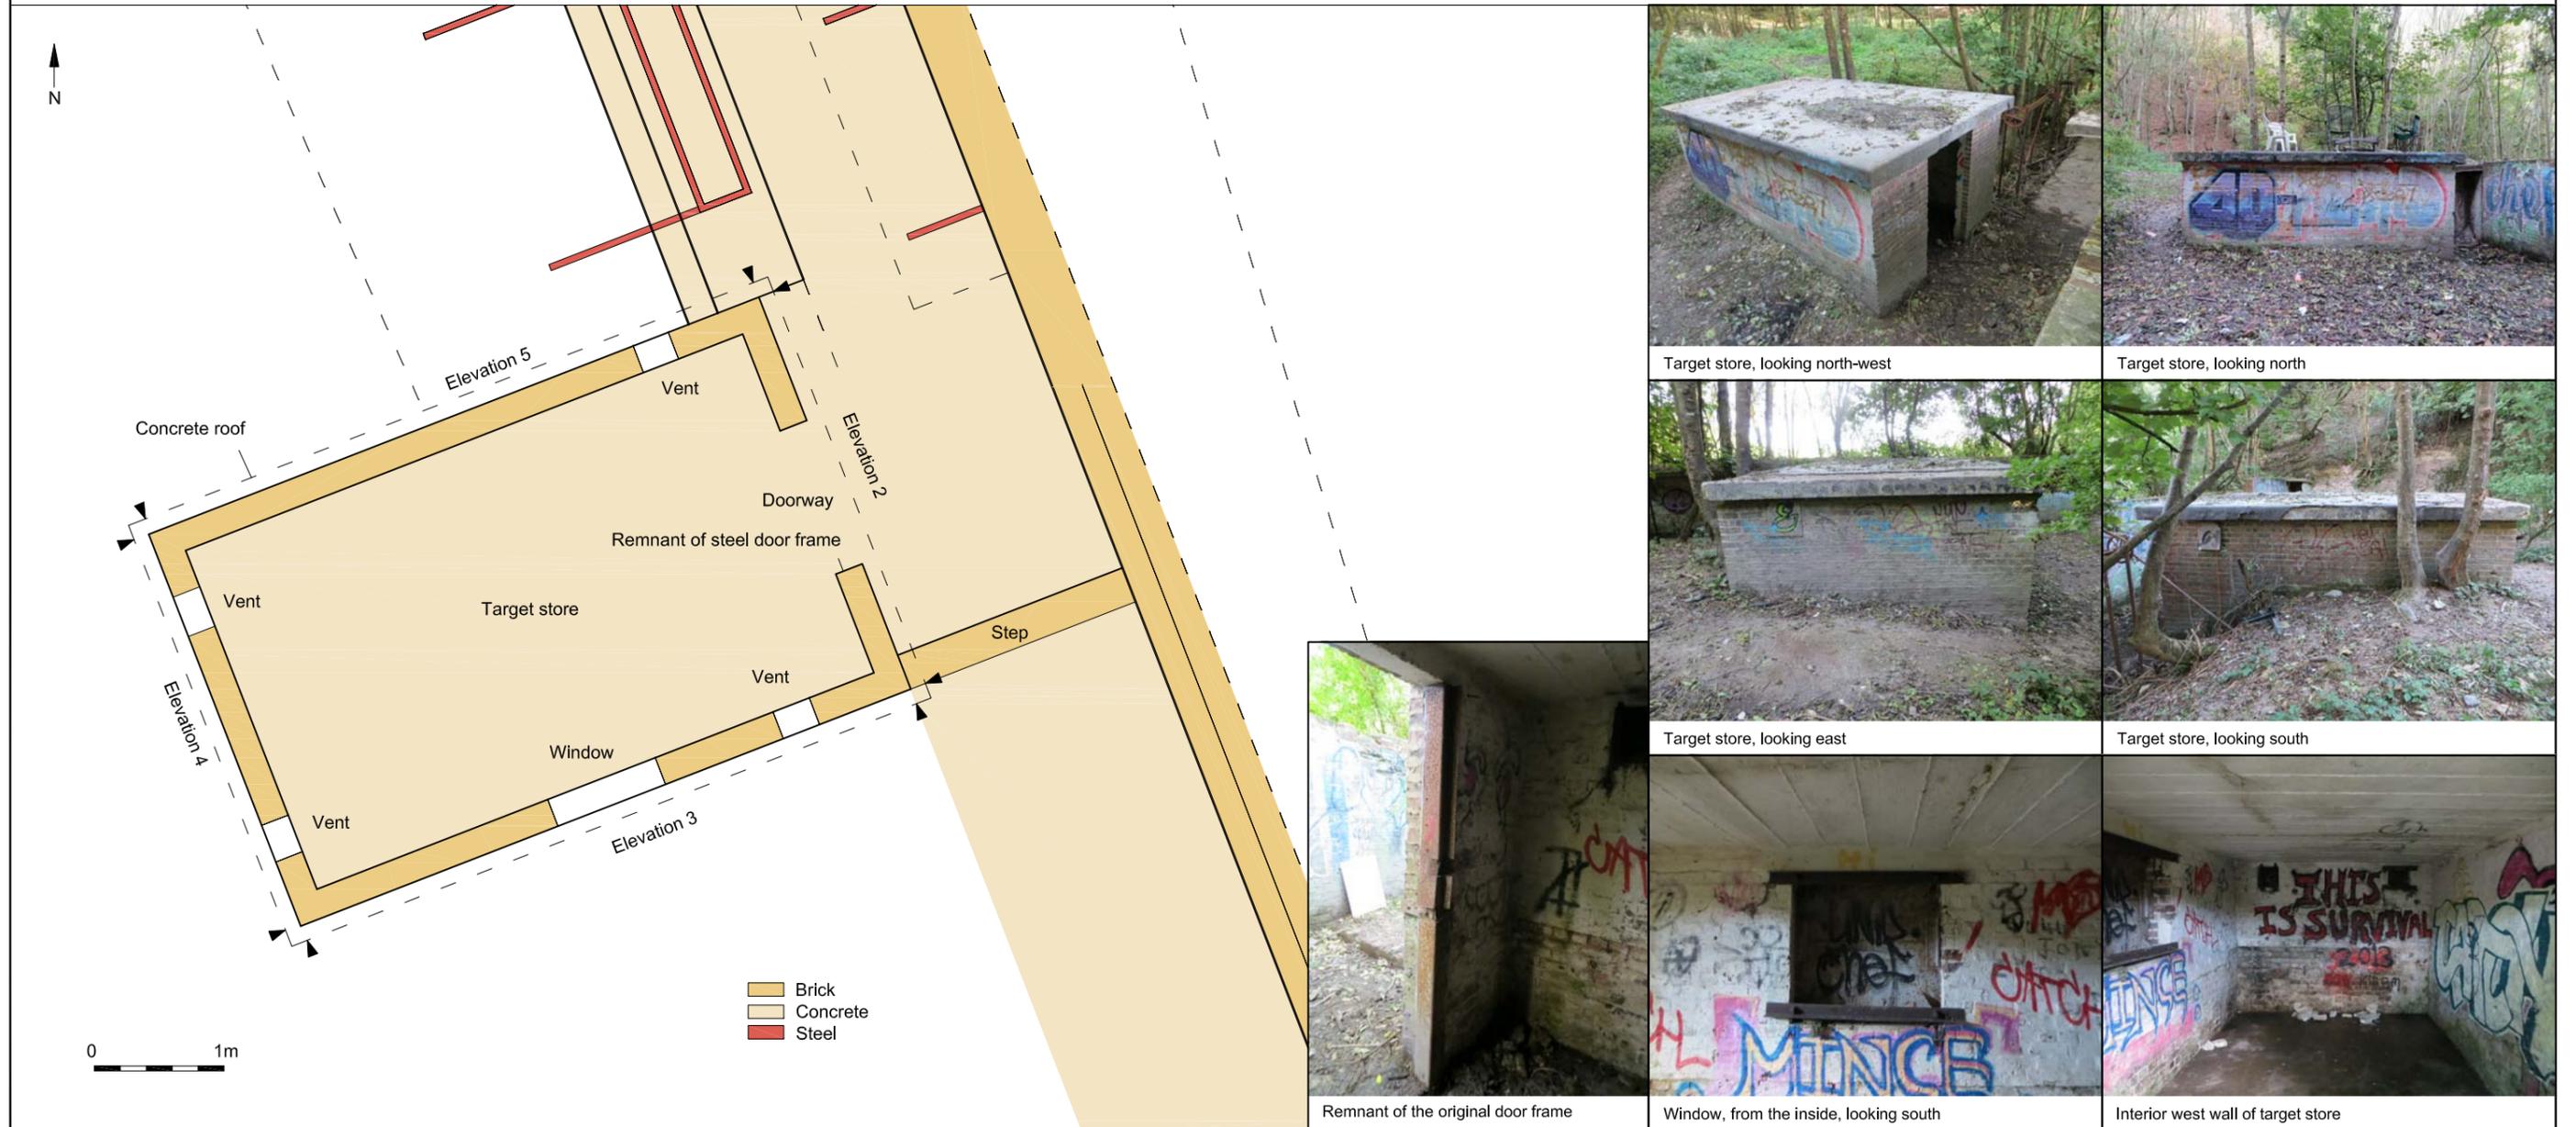
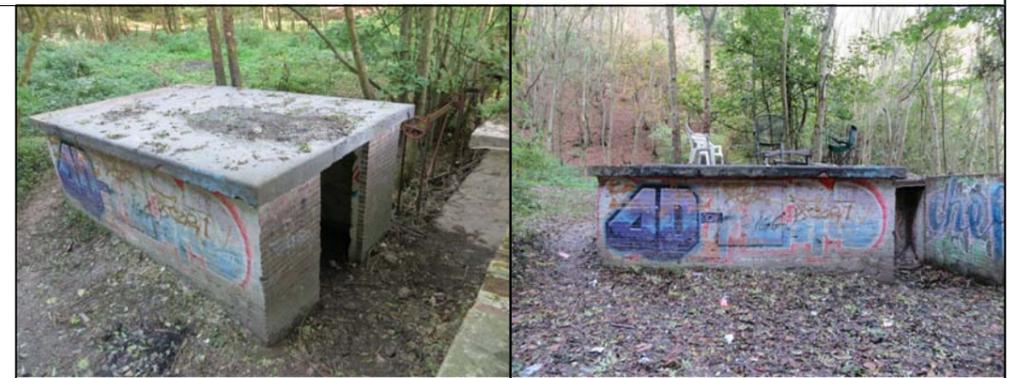
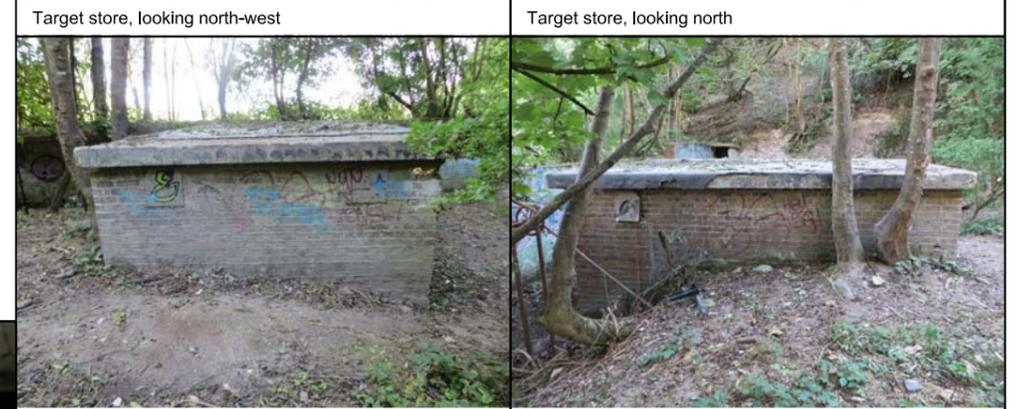
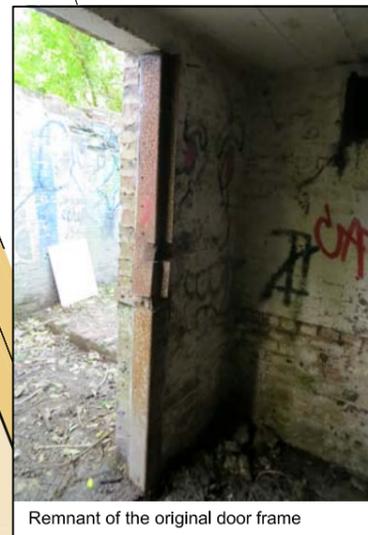
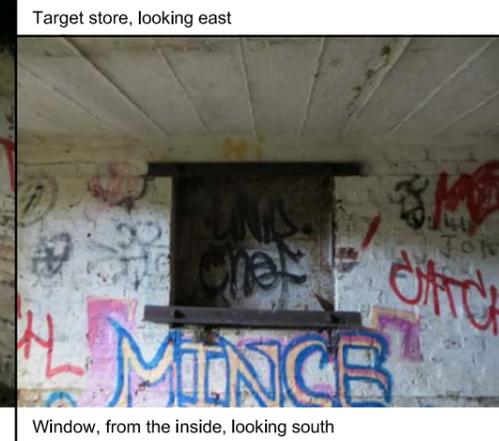
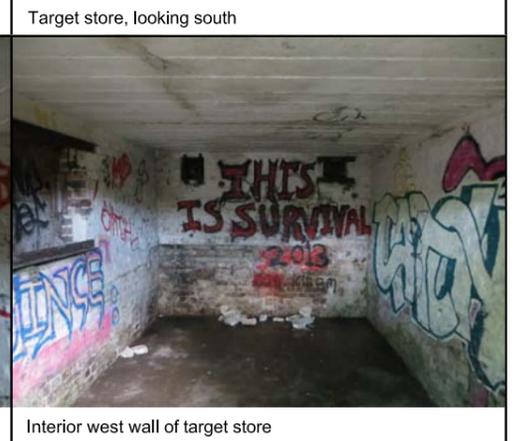
Fig. 18: Elevations of target store

- 4.3.1 At the south end of the markers' gallery, immediately south of target frame 1, is the target store (figures 14 and 18). At 5m by 3.2m, the structure provided secure storage for the wooden targets and necessary additional materials. It originally featured a heavy steel door (recently reused as a bicycle ramp in the workshop area and now covered in chalk rubble) and one window, facing south. The window and four ventilation holes are now covered by steel plates, but would originally have had offered protected ventilation, possibly wire mesh for the vents and shutters for the window. A steel strip, on the southern entrance wall is all that remains of the original door frame.

- 4.3.2 A concrete reinforced roof overhangs the brick wall structure by 120mm – on the underside of the overhang, is a drip groove, running around the roof to stop rainwater from the roof running down the walls. Where the roof is visible inside the building, the mould left by the wooden shuttering used when the concrete was wet can clearly be seen. The concrete roof of the target store protrudes slightly over the top of the retaining wall and mantlet (not a desirable situation when the range is being used, as it may represent a ricochet issue), which suggests the top of the mantlet has eroded somewhat over time, exposing the concrete of the target store roof.

- 5.3 A new door on the target store would extend the life span of the structure as well as potentially providing a store for equipment used in maintaining the site. The existing door would seem to have been buried under chalk and soil which has slumped onto it from the valley side, in the workshop area. This slumping has been hastened by the recent use of the area as a bicycle ramp, and the overall condition has deteriorated rapidly in the last four years. Clearance of the rubble and door would aid in the cessation of the destructive activity.
