**Steyning Rifle Range:
History and Record of Existing Features**

**Compiled on behalf of the Steyning Downland Scheme
Justin Russell, February 2017**

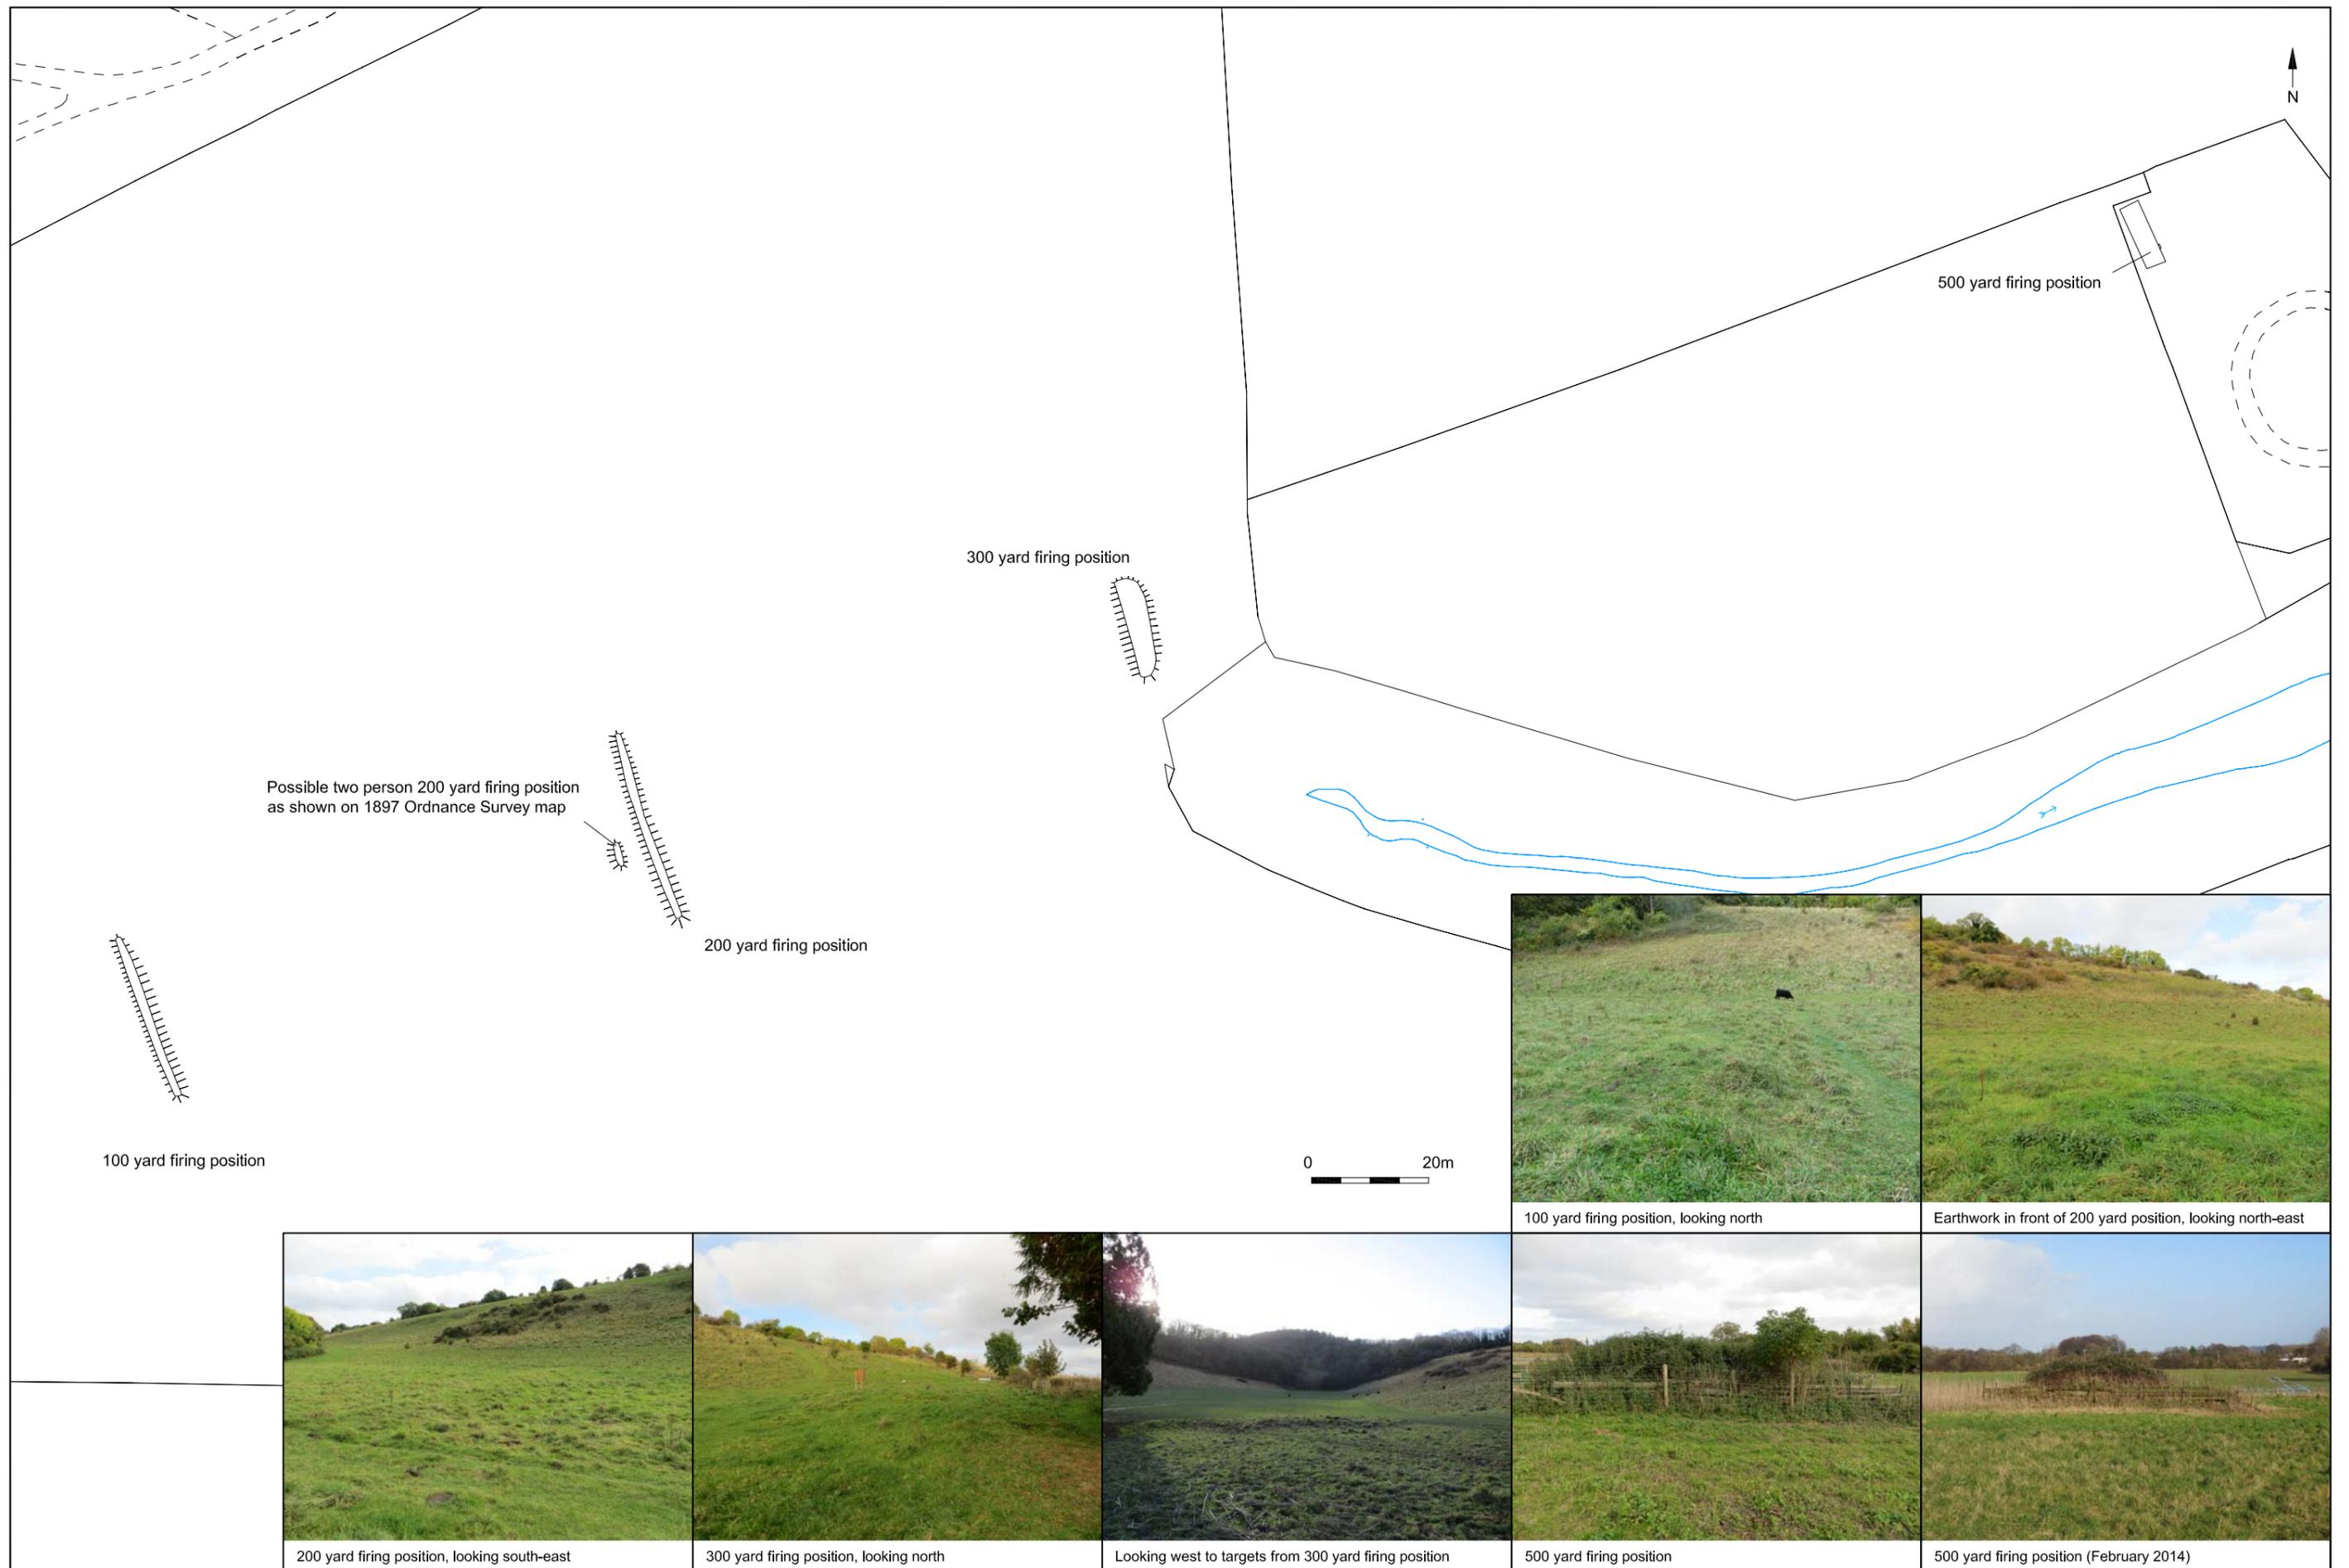
Fig. 19: 100, 200 and 300 yard firing positions

4.6.1 The first firing position consists of a low bank, 29m in length, up to 3.8m wide at its base and 0.3m in height (figure 19). Constructed to accommodate up to eight people firing at any one time, the 1946 aerial photograph shows this to be only 19m in length, suggesting that the extra 10m on the southern extent was added sometime after this date. The firing position currently shows no sign of the revetment visible on the 1946 aerial photograph and all sides slope gently.

4.7.1 At 33m long, up to 4m wide and 0.3m in height, this is the longest of the firing positions. Comparison with the 1946 aerial image once again shows the wartime length to have been significantly shorter, at only 15m. As with the 100 yard position, no signs of the revetment indicated on the 1946 aerial photograph are now present.

4.8.1 Out of the three firing positions in the valley, this is the one that matches best with the 1946 aerial photograph in its dimensions (17m long and 6.5m wide). It is currently difficult to define on its southern edge due to wear from an informal path around the trees surrounding the spring. Four timber lined firing pits are noted to have been dug here in the 1950s, in accordance with range construction of the period (Steve Handerer, *pers. comm.*).

- 5.6 The 100, 200 and 300 yard firing positions are in a very stable location, in the cattle managed grassland.
- 5.7 The 500 yard firing position is in a semi-collapsed state and many of the iron bars holding up the telegraph pole revetting having been pushed out of shape. A general clearance of the vegetation around the position would allow for a greater understanding of its current state and perhaps present an opportunity for limited repair work to be carried out.

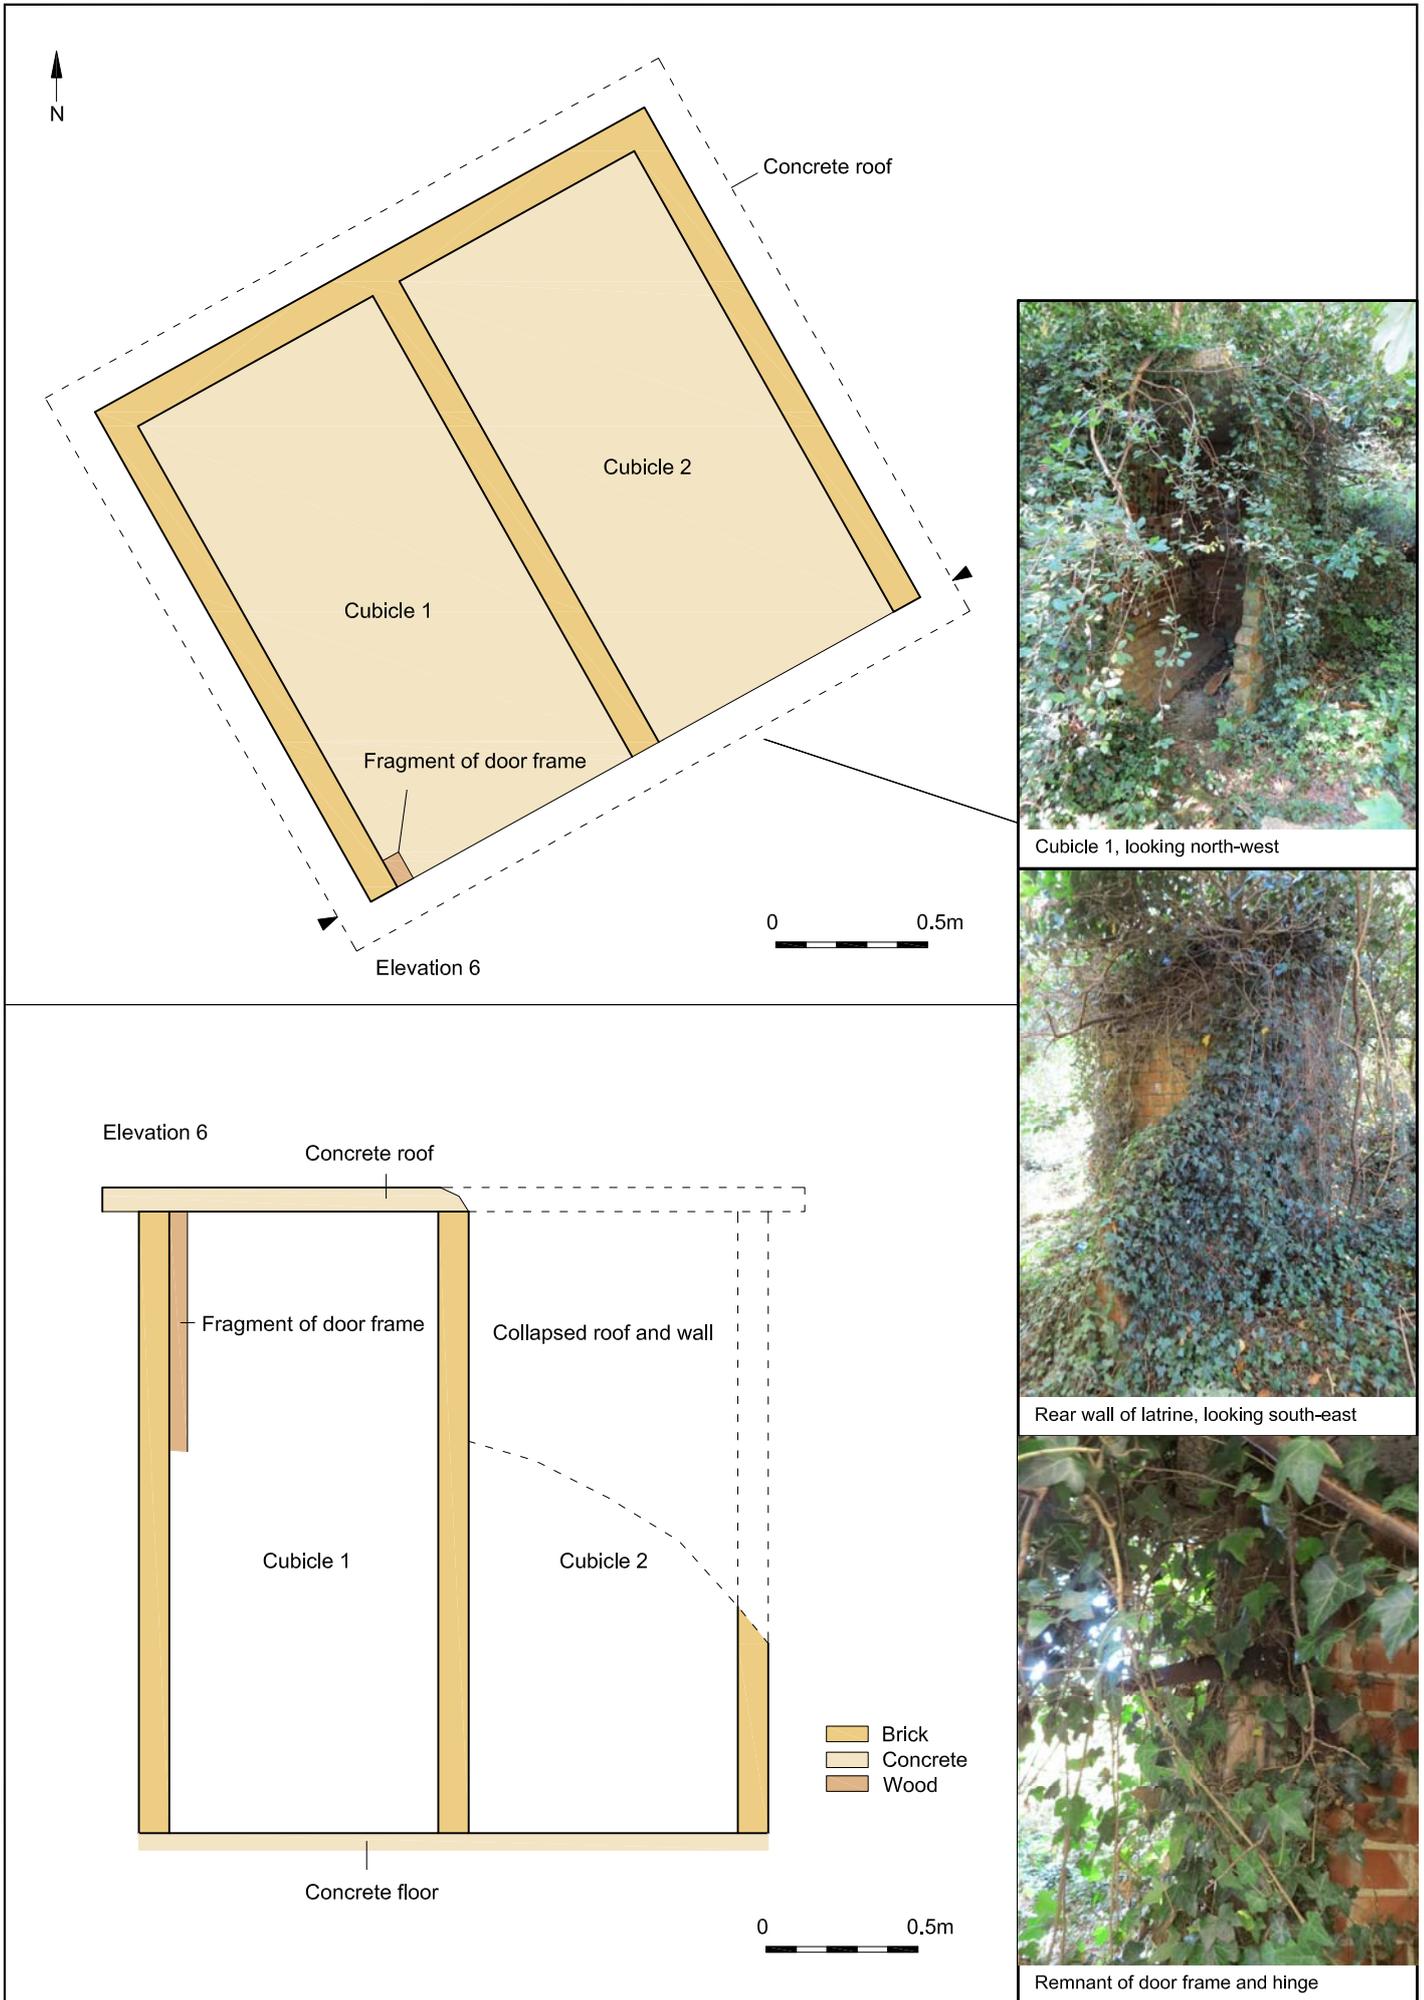
Fig. 21: Plan and elevation of latrine block

4.10.2 The latrine block that currently stands in this area is an additional structure to the main building shown on the maps - located 3m to the east, it survives, though in poor condition (figure 21). That the latrine is not marked on any map is surprising, although the latrine in the target area is also unmarked. Dating of the latrine block is uncertain, though it is likely to date either to the Second World War rebuild, or perhaps more likely with the post-war consolidation of the site. Measuring 1.8m by 2.05m, the latrine block consists of two cubicles each 0.88m wide. Remnants of the wooden doorframe can be seen on the western cubicle, whilst the eastern cubicle is in a poor condition, the concrete roof having collapsed above it and the wall too in a derelict state.

- 5.8 The only structure posing an immediate threat to safety is the latrine block at the turning circle. Half of the concrete roof and brickwall have so far collapsed and it would seem likely that the rest will follow soon. It would be difficult to envisage or justify repair to the structure, so perhaps demolition to footing level is the best option (allowing the structure to remain part of the historic landscape). If this was the case, perhaps an archaeological investigation of the immediate surrounding area would be a good balance, to try and locate the building the latrine was associated with.
